Technical Note N- 1081

DEEP-OCEAN BIODETERIORATION OF MATERIALS -
SIX MONTHS AT 6,000 FEET

APRIL 1970

NAVAL CIVIL ENGINEERING LABORATORY
Port Hueneme, California 93041

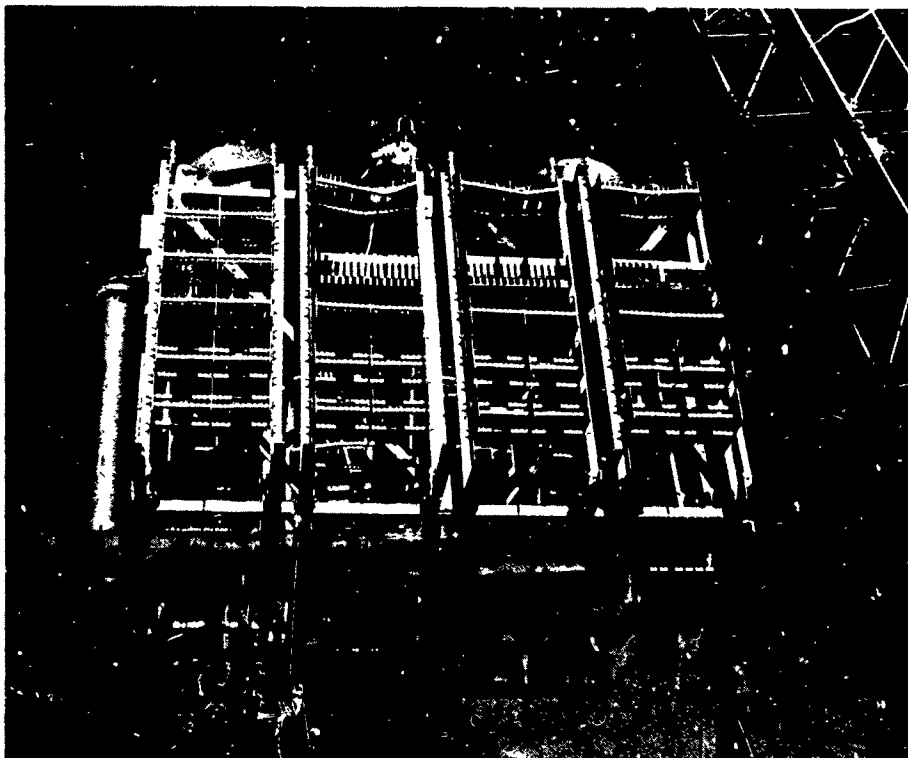
Figure 6. STU I-5 recovered from the sea.

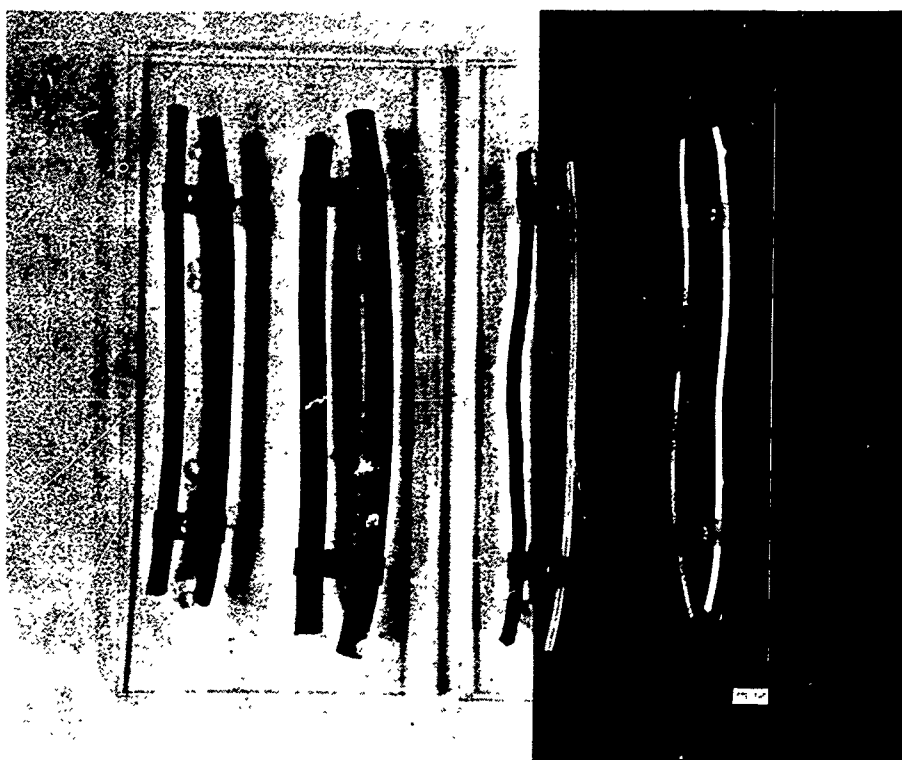
Figure 12. Plastic and rubber insulated electrical cable test specimens after recovery from the sea.
